# Manhole Inspection Summary

Manhole # S31AA\_010MH

Insp Date: **12/14/07 3:55 PM**

**Location** Address: **420 DRUID HILL AVE**

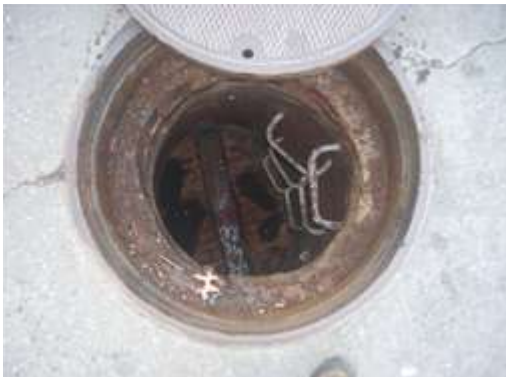
FRAME IS TOO LARGE

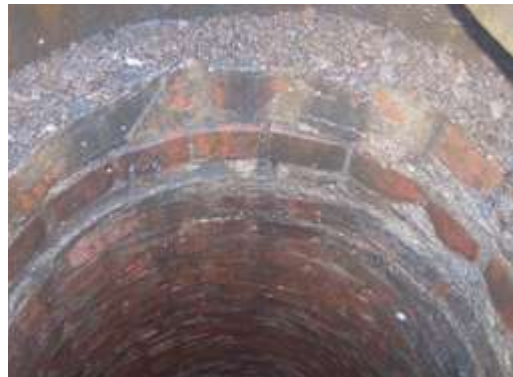
Defect 1

Condition: ☐ Sound ☐ Cracked ☐ Root Intrusion ☒ **Loose Brick** ☐ Deteriorated

CORBEL BRICKS LOOK A LITTLE LOOSE

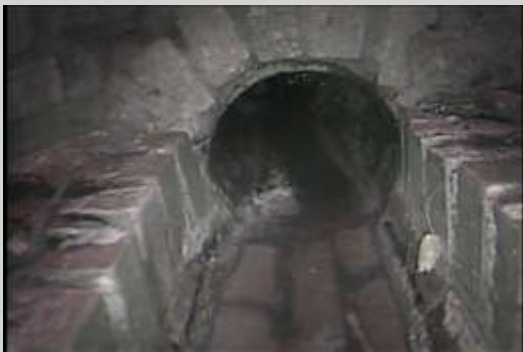
12 O'Clock Outflow

Pipe Height: **8.4** (in.) Rod and Bar (Angled)  
Pipe Material: **Clay** ☐ Pipe Lined  
Invert Depth: **9.42** (ft.) Flow Characteristics: **Slow**  
Deposits: ☐ None ☐ Mud ☒ **Sludge** ☐ Debris ☐ Grease  
Silt Depth: **1** (in.) Deposits Extent: **Light**  
Infiltration: **None** Pipe Seal Cond: **Sound**

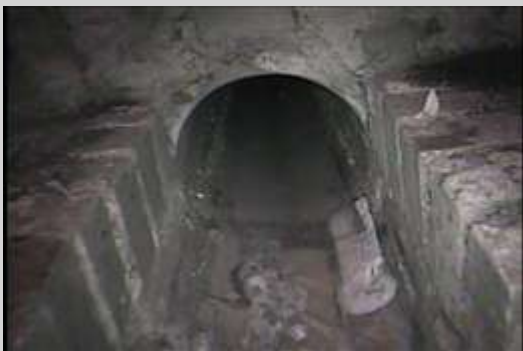
6 O'Clock Inflow

Pipe Height: **8.4** (in.) Rod and Bar (Angled)  
Pipe Material: **Clay** ☐ Pipe Lined  
Invert Depth: **9.26** (ft.) Flow Characteristics: **Slow**  
Deposits: ☒ None ☐ Mud ☐ Sludge ☐ Debris ☐ Grease  
Silt Depth: (in.) Deposits Extent:  
Infiltration: **None** Pipe Seal Cond: **Sound**
